**A CASE STUDY ON THE RISK OF ROAD
ACCIDENTS CAUSED BY DETERIORATING
ROAD CONDITIONS CONSEQUENCE OF
CRUMBLING INFRASTRUCTURE AT JALAN
KUALA KANGSAR (FT001), IPOH, PERAK.**

CIVIL ENGINEERING DEPARTMENT

SESSION II 2023/2024

**A project report/thesis submitted in partial fulfilment of the
requirement for the award of the degree in Bachelor of Civil
Engineering Technology with Honours**

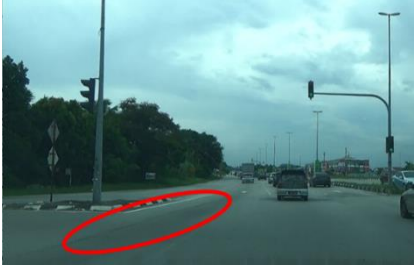
<p>1. Longitudinal crack</p>

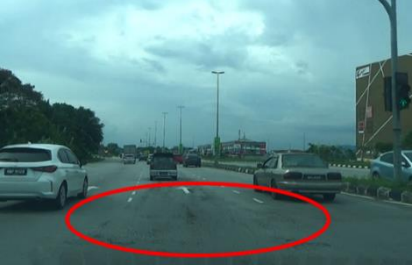
<p>2. Crocodile crack</p>

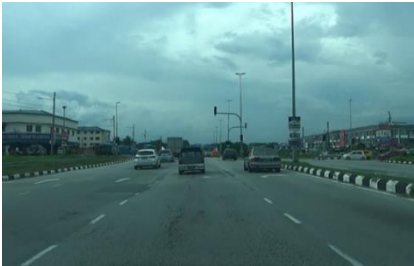
<p>3. Polishing</p>

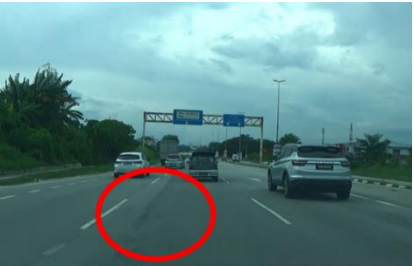
<p>4. Rutting & Longitudinal Crack</p>

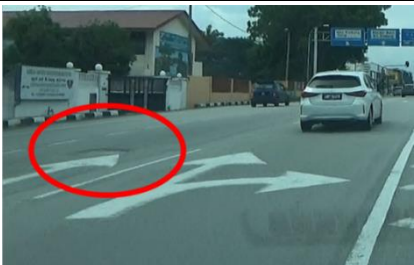
<p>5. Delamination & Depression</p>

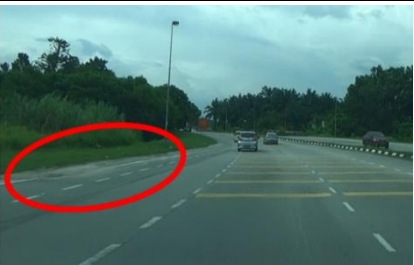
<p>6. Edge crack</p>

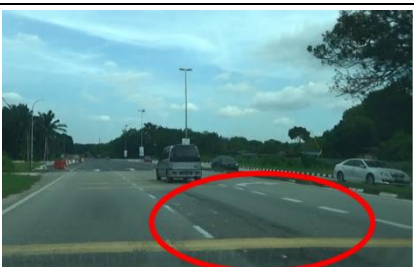
<p>7. Shoving and Delamination</p>

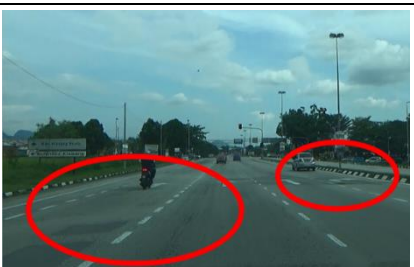
<p>8. Rutting and Depression</p>

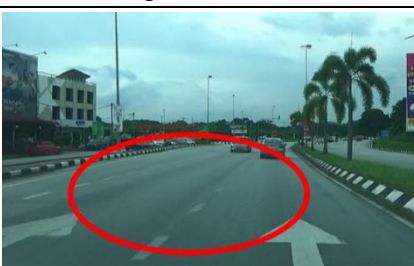
<p>9. Line marking not clear</p>

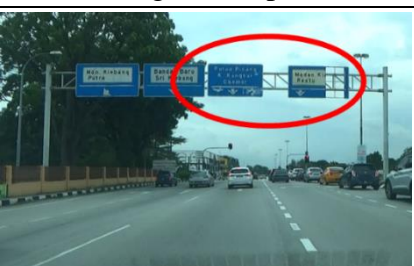
<p>10. Signage not clear for sight distance</p>

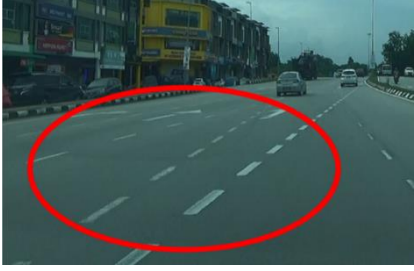
<p>11. Confusing line marking</p>

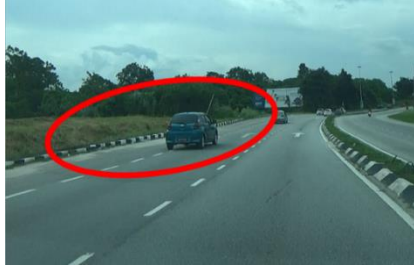
<p>12. Curve Chevron Signage is not clear and not enough</p>

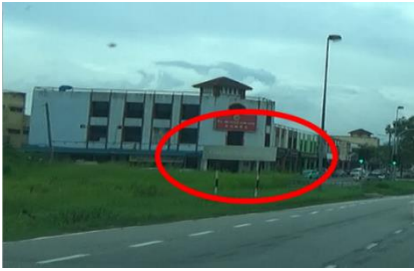
<p>13. Signage not clear</p>

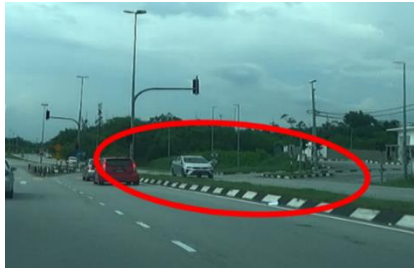
<p>14. No signage to turn</p>

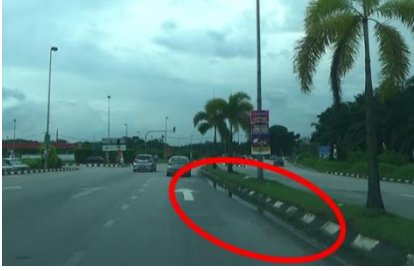
<p>15. Stagnant water and no drain</p>

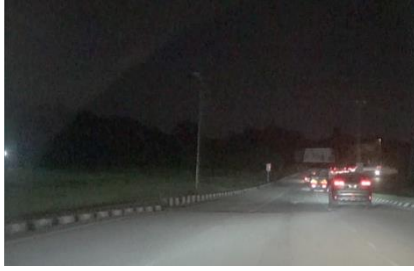
<p>16. Streetlight does not function</p>

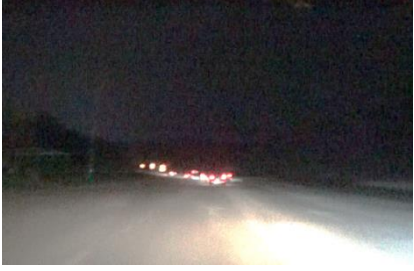
<p>17. No streetlight, guardrail, road stud</p>

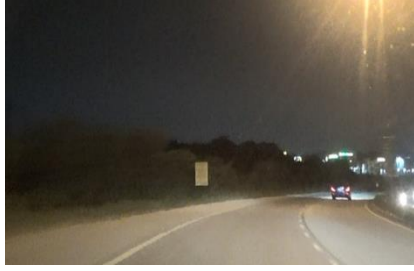
<p>18. No detour signage and reduced speed limits</p>
