CLEANROOM CONSTRUCTION ERRORS TO AVOID: A CIVIL ENGINEER'S PERSPECTIVE ON ACHIEVING ZERO-DEFECT DELIVERY IN SPACE SECTOR

Sravan Kumar P¹, Mohit Chaturvedi²

¹Engineer-SD, UR Rao Satellite Center, Bengaluru, India.

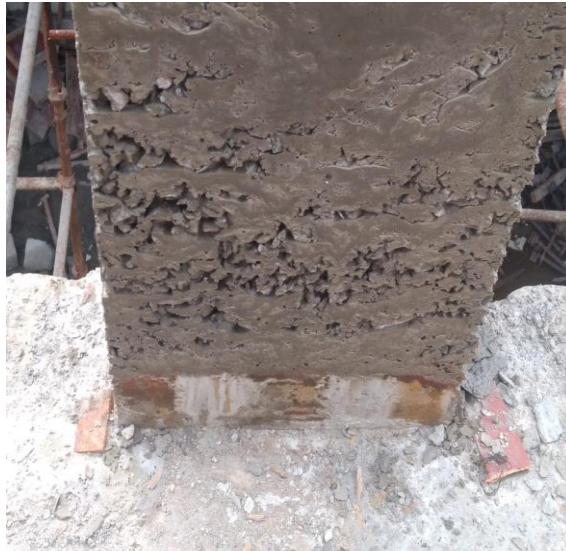
Honeycombing refers to voids, coarse aggregate exposure, or porous concrete zones due to incomplete compaction or poor mix flow. Poor compaction due to congested reinforcement, inaccessible vibrator insertion points near beam-column junctions, segregation due to long pump discharge drop, leaky formwork allowing mortar loss, Improper concrete mix design (low workability, high aggregate size) etc., can cause Honeycombing in the RCC members. This may lead to,

Fig 1. Typical illustration of Honeycombing in RCC members

- Air Leakage Paths: Honeycombed areas are highly porous, creating uncontrolled air paths through the roof or ceiling surface — compromising room pressurization balance.
- Dust Generation: Loose particles from weak concrete continuously shed dust — a major contamination source in Class 10000–100000 cleanrooms.
- Water Ingress: Porosity allows moisture migration, which affects humidity and causes microbial growth risk inside the cleanroom.
- Coating Failure: Epoxy or PU paint on slab soffit delaminates due to poor substrate integrity.
- Thermal Leakage: In satellite testing, honeycombed areas degrade thermal insulation performance of roof envelopes.

- Use SCC (Self-Compacting Concrete) in congested or inaccessible zones.
- Seal formwork joints tightly to prevent grout leakage (use mastic tape).
- Epoxy grouting or micro-concrete repair for any honeycombing found before false ceiling installation.

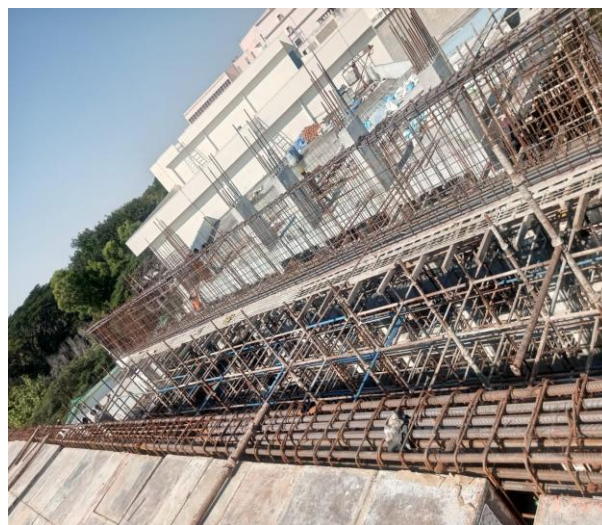
Reinforcement congestion occurs when bars are closely spaced, leaving inadequate space for concrete flow and compaction — especially in long-span slabs (like 6 m × 25 m). This is caused by using large diameter bars (e.g. 25–32 mm) at close spacing in long spans, overlapping of top and bottom reinforcement with conduit and duct inserts, improper detailing near supports and openings (duct cut-outs, AHU risers).

Fig 2. Congestion of Reinforcement in Roof Beam / Slab

- Adopting SCC or pumpable concrete mix with smaller aggregates.
- BIM coordination before slab pour to resolve rebar–duct–sleeve clashes.
- Ensure adequate clear spacing between bars as per IS 456:2000.
- Provide mechanical couplers to reduce lap congestion.

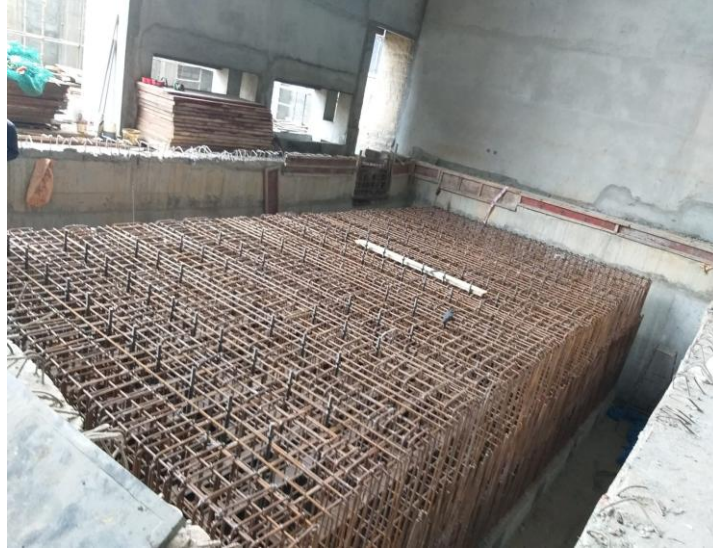
Vibration-isolated foundations often require thick RCC blocks with dense reinforcement, sometimes with embedded anchors for isolator plates leading to congestion.

This causes honeycombing due to poor concrete flow and voids below embedded plates or bolts. Cleanroom is impacted further due to reduced stiffness of the foundation block which generates altered vibration frequency response. This can be prevented by use of self-compacting concrete (SCC) for congested blocks.

Fig 3. Reinforcement Congestion in Foundation Block

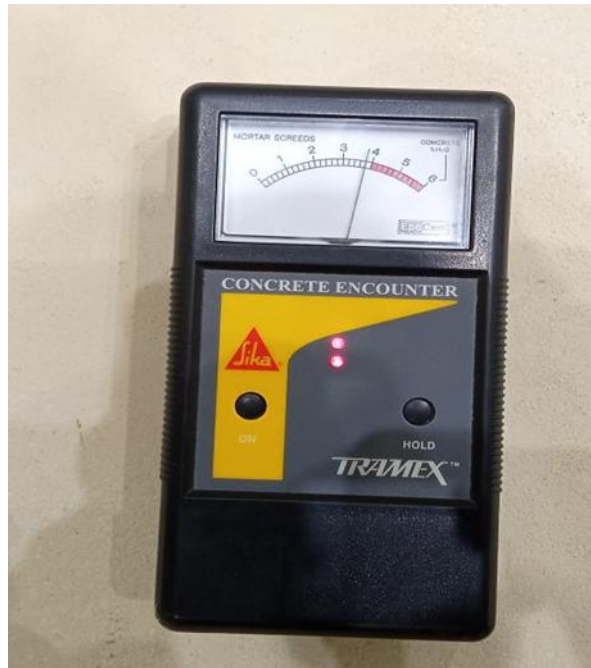
- Accurate moisture measurement: Moisture content must be checked using a concrete moisture meter. Use of a wood moisture meter is inappropriate and leads to false readings.

Fig 4. Moisture meter

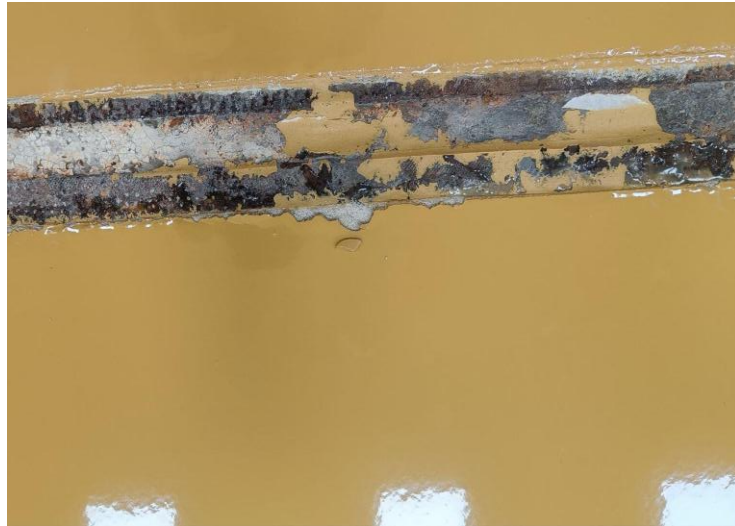
Fig 5. Error in laying ESD flooring at the steel and concrete interface

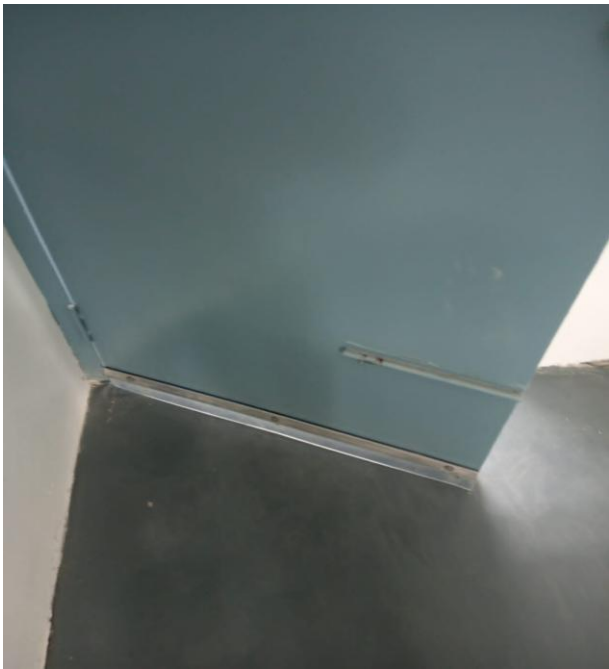
Fig 9. Sealing strip at the bottom of the door

- No gaps at the bottom of door shutters shall be left. If inevitable, the gaps shall be covered with PVC or treated rubber flaps (flexible type).
- All steel elements, structural and components provided in cable trench steel doors (if any) and OH cranes shall be painted with epoxy resin based paint.
