**A CASE STUDY ON THE RISK OF ROAD
ACCIDENTS CAUSED BY DETERIORATING
ROAD CONDITIONS CONSEQUENCE OF
CRUMBLING INFRASTRUCTURE AT JALAN
KUALA KANGSAR (FT001), IPOH, PERAK.**

CIVIL ENGINEERING DEPARTMENT

SESSION II 2023/2024

**A project report/thesis submitted in partial fulfilment of the
requirement for the award of the degree in Bachelor of Civil
Engineering Technology with Honours**

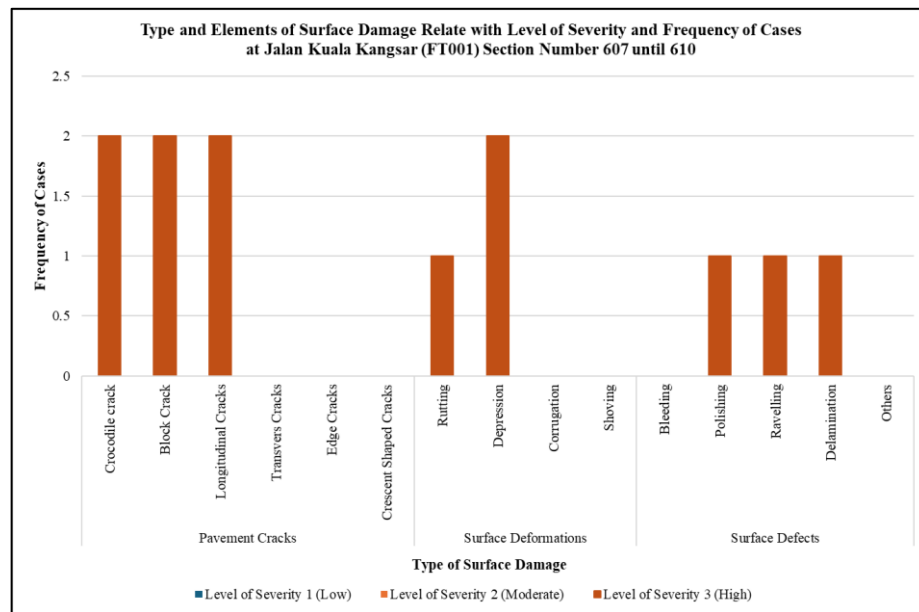
Figure 4.16: Level of Severity via of Type and Elements of Surface Damage at Jalan Kuala Kangsar (FT001) Section Number 607 until 610

Figure 4.16 above shows that the level of severity is at level 3, which is a high level means that the type of damage to the road surface is severe. This shows that the existing damage is at a critical level and has a risk of road accidents to road users on Jalan Kuala Kangsar (FT001) if no maintenance action is taken by the authorities.

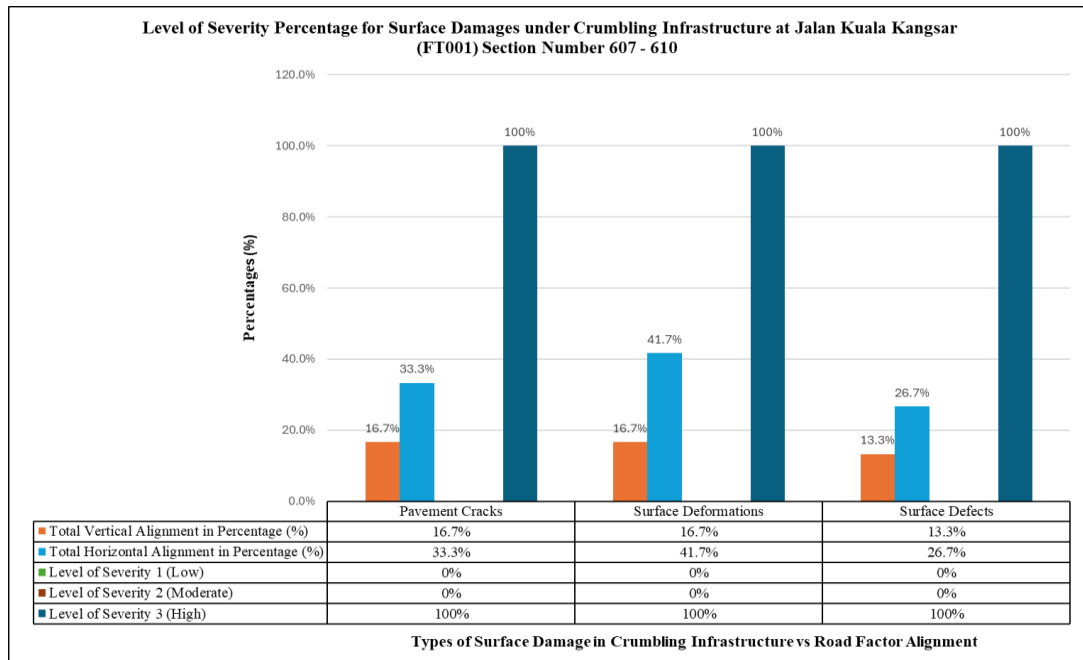
Figure 4.19: Level of Severity in Percentage (%) for Surface Damage under Crumbling Infrastructure at Jalan Kuala Kangsar (FT001) Section Number 607-610

Figure 4.19 above shows that pavement cracks result in 16.7% vertical alignment and 33.3% horizontal alignment issues. All these cracks are categorized as high severity (Level 3), indicating that pavement cracks severely disrupt the road surface, making driving conditions dangerous due to significant misalignment.
